# Stucco Inspection Report

Sample

## Project Information

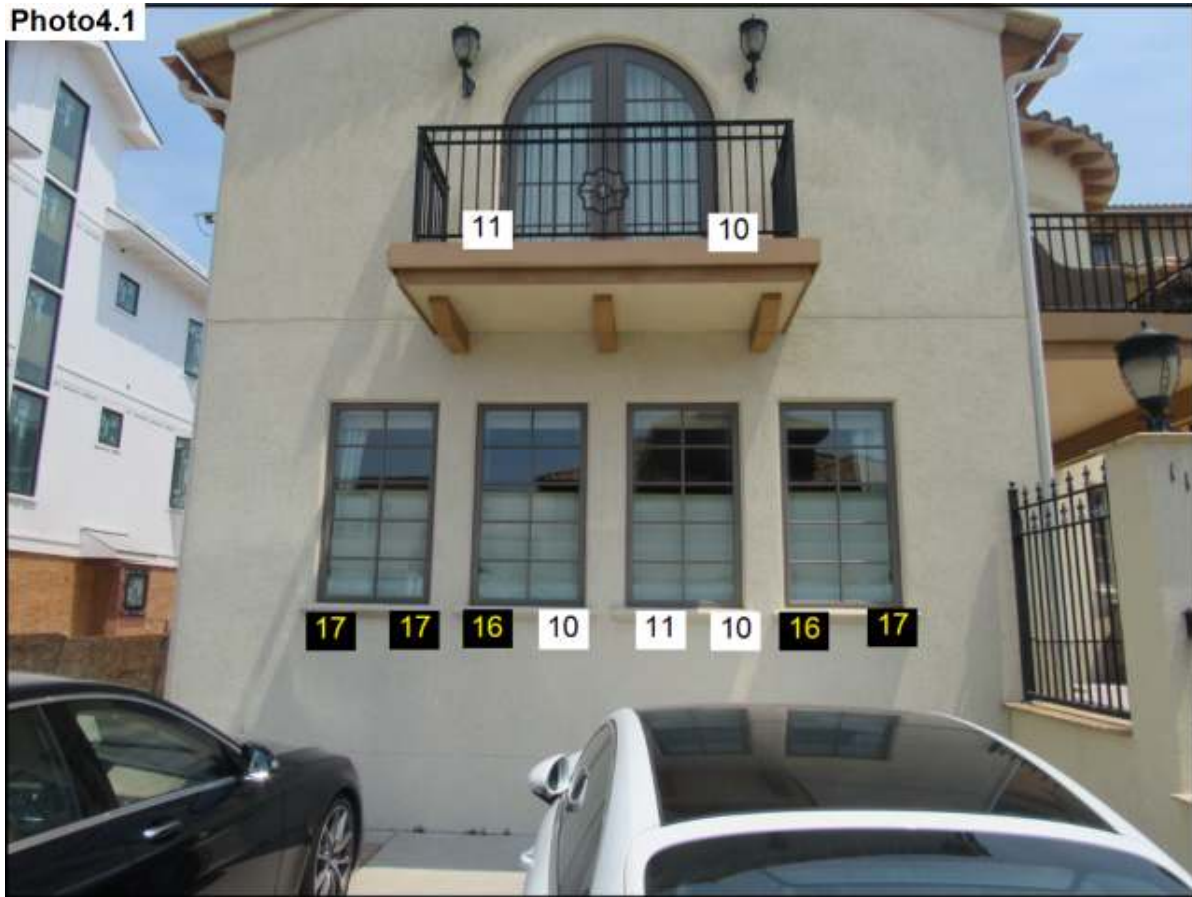
Photo4.1

| Item | Item Description | Applies to Entire Bldg | Observations / Comment |
|---|---|---|---|
| | General | | Marginal readings were measured on this section. |
| | Soft Joints/Caulk Details | | Soft joints were installed. |

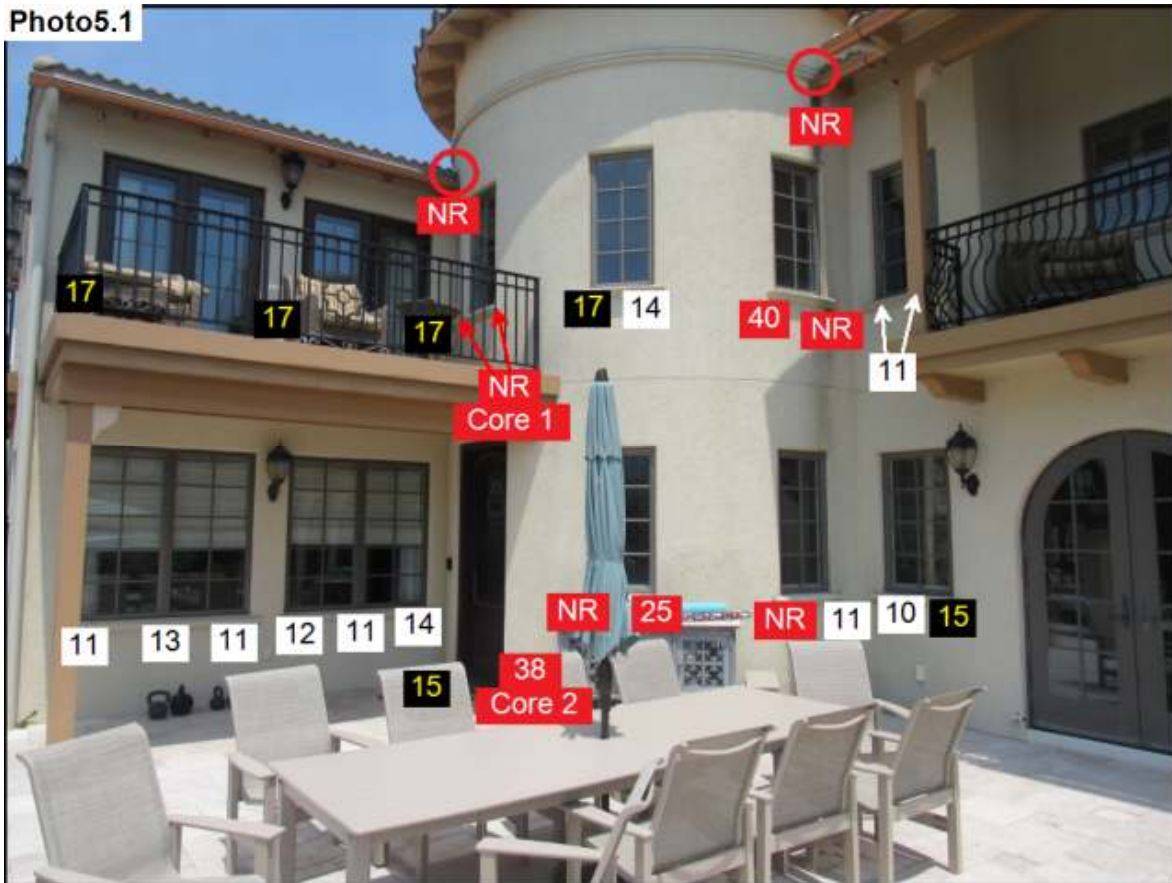
Photo5.1

| Item | Item Description | Applies to Entire Bldg | Observations / Comment |
|---|---|---|---|
| | General | | No resistance readings were measured on this section, consult a certified stucco remediator for repairs. |
| | Soft Joints/Caulk Details | | Soft joints were installed. |
| | Red Circles | | Indicates kickout diverters were not installed. |
| | Core | | Core 1 revealed rotted plywood. |
| | Core | | Core 2 revealed damp plywood. |

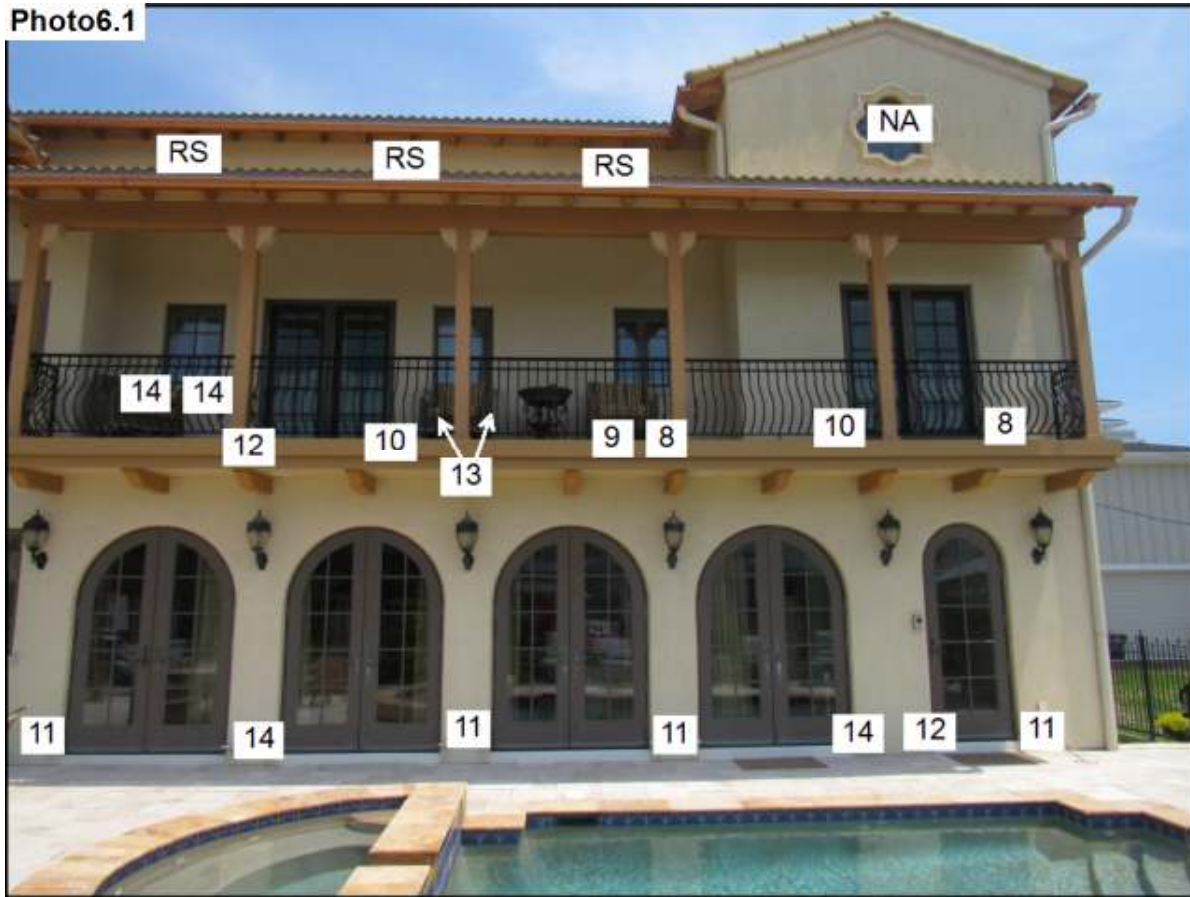
Photo6.1

| Item | Item Description | Applies to Entire Bldg | Observations / Comment |
|---|---|---|---|
| | General | | Normal readings were measured on this section. |
| | Soft Joints/Caulk Details | | Soft joints were installed. |
| | RS | | Windows are in the roof step flashing, so were not tested. |
| | NA | | Not accessible for testing. |

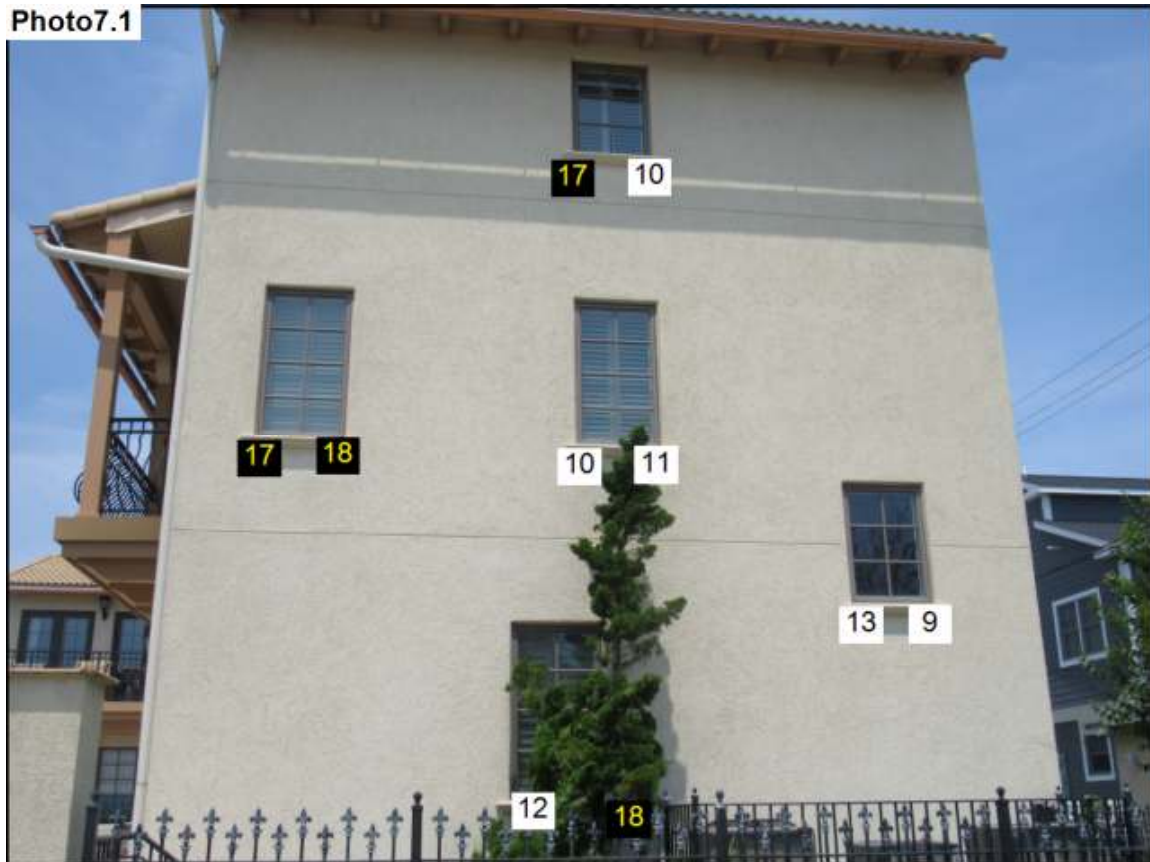
## Right Elevation 1

| Item | Item Description | Applies to Entire Bldg | Observations / Comment |
|---|---|---|---|
| | General | | Marginal readings were measured on this section. |
| | Soft Joints/Caulk Details | | Soft joints were installed. |

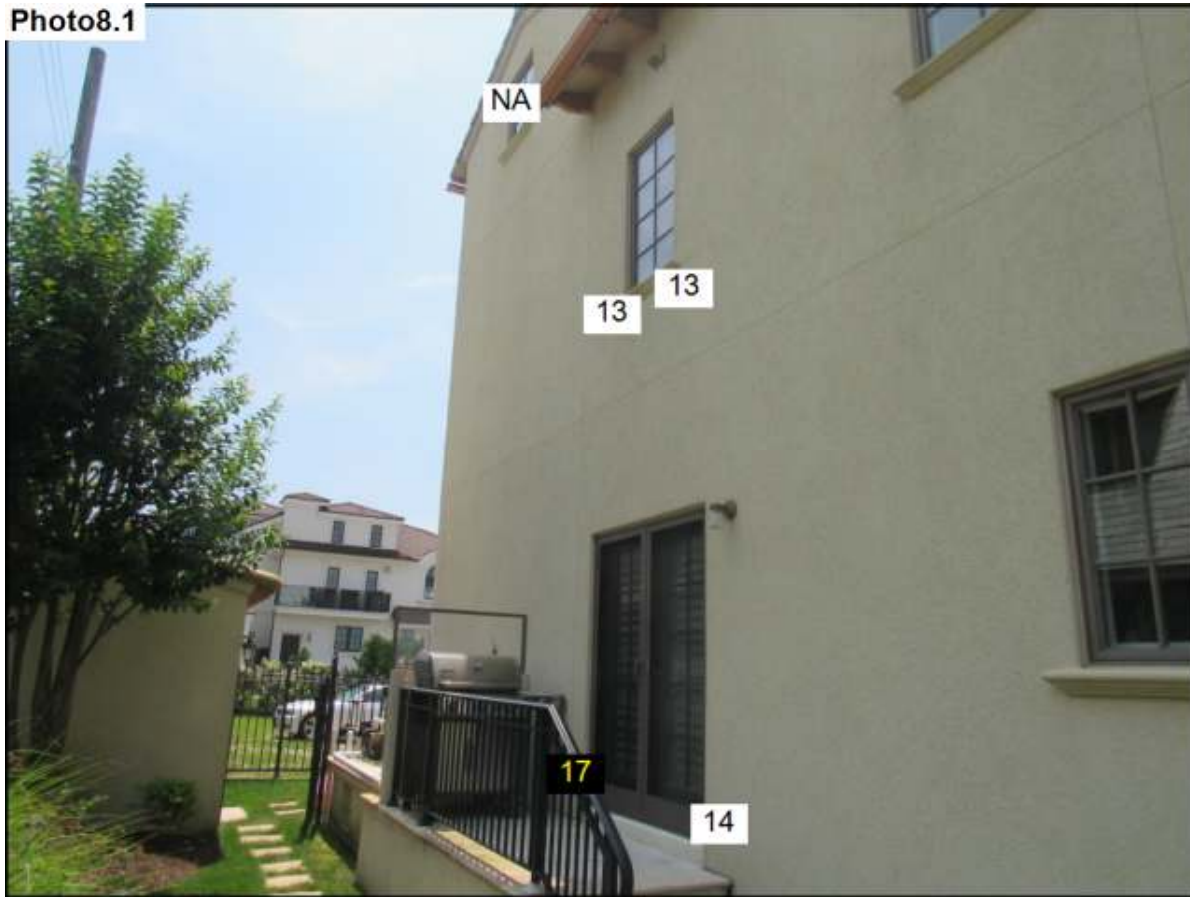
Photo8.1

| Item | Item Description | Applies to Entire Bldg | Observations / Comment |
|---|---|---|---|
| | General | | A marginal reading was measured on this section. |
| | Soft Joints/Caulk Details | | Soft joints were installed. |
| | NA | | Window not accessible for testing. |

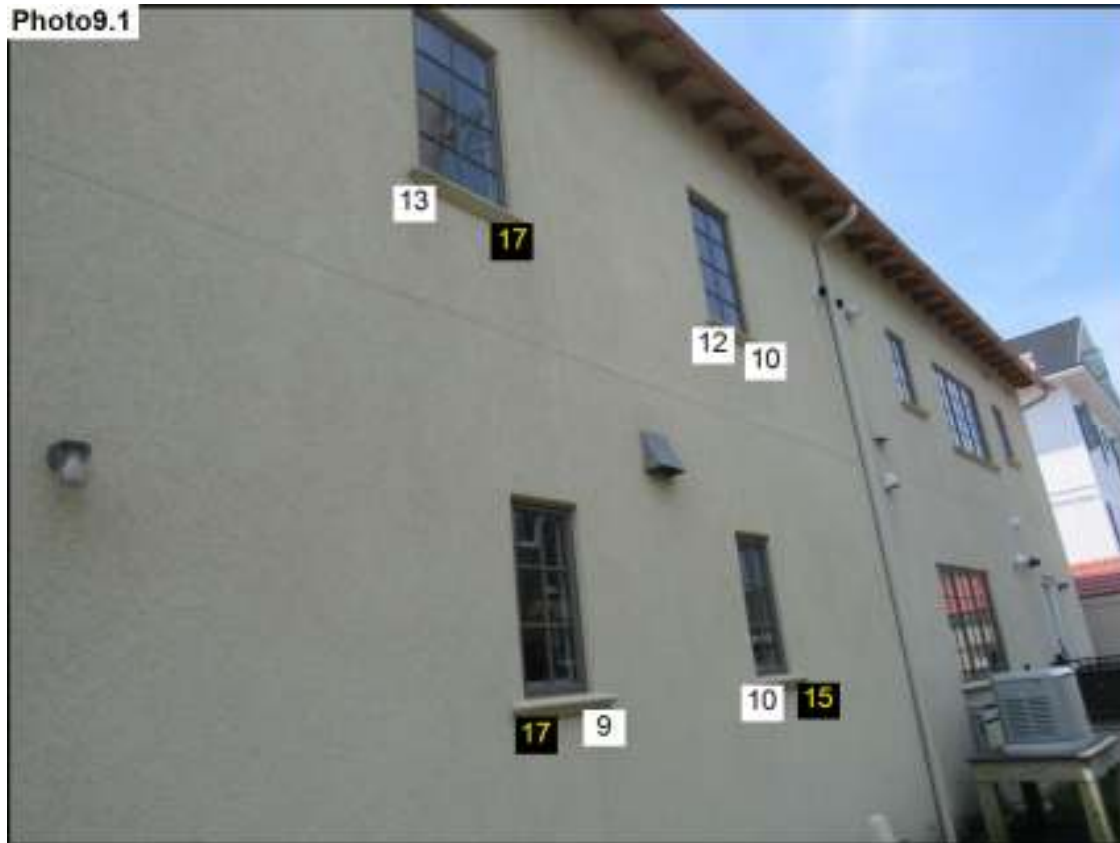
## Rear Elevation 2

| Item | Item Description | Applies to Entire Bldg | Observations / Comment |
|---|---|---|---|
| | General | | Marginal readings were measured on this section. |
| | Soft Joints/Caulk Details | | Soft joints were installed. |

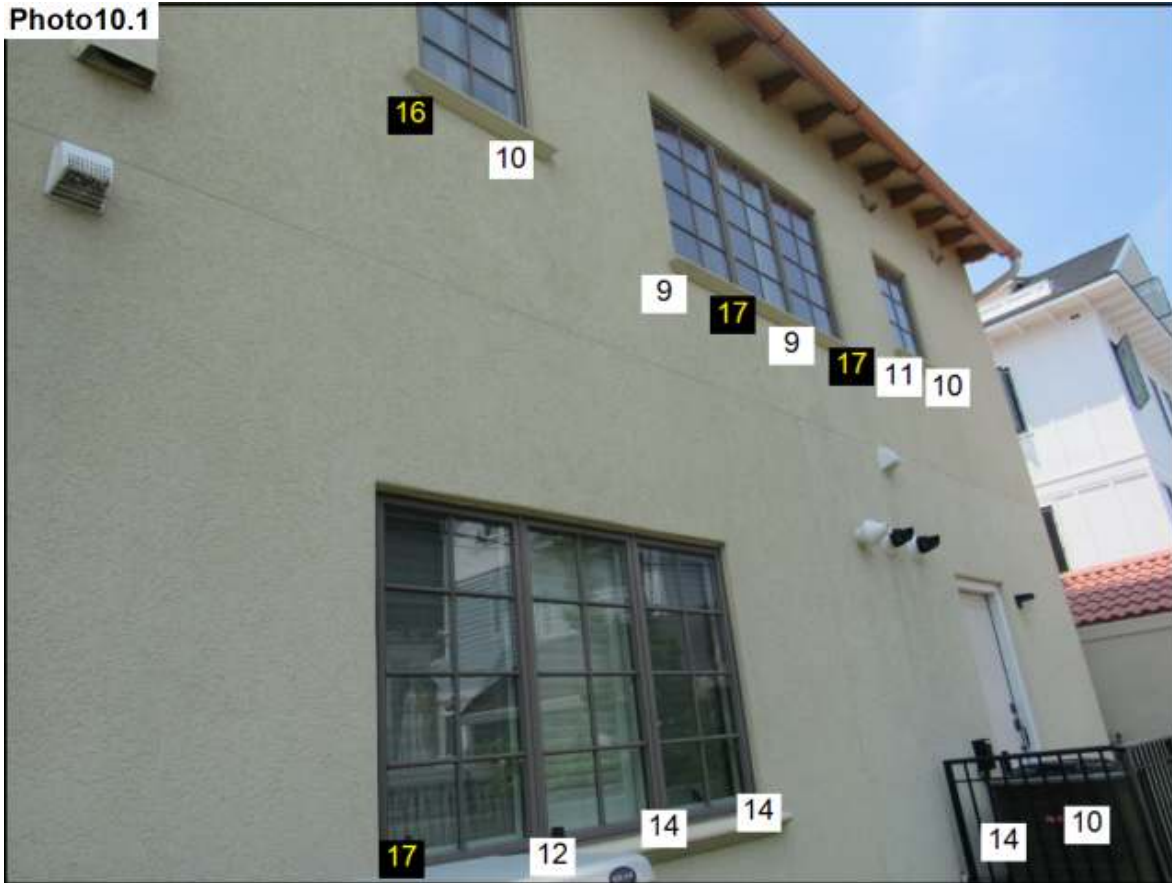
Photo10.1

| Item | Item Description | Applies to Entire Bldg | Observations / Comment |
|---|---|---|---|
| | General | | Marginal readings were measured on this section. |
| | Soft Joints/Caulk Details | | Soft joints were installed. |

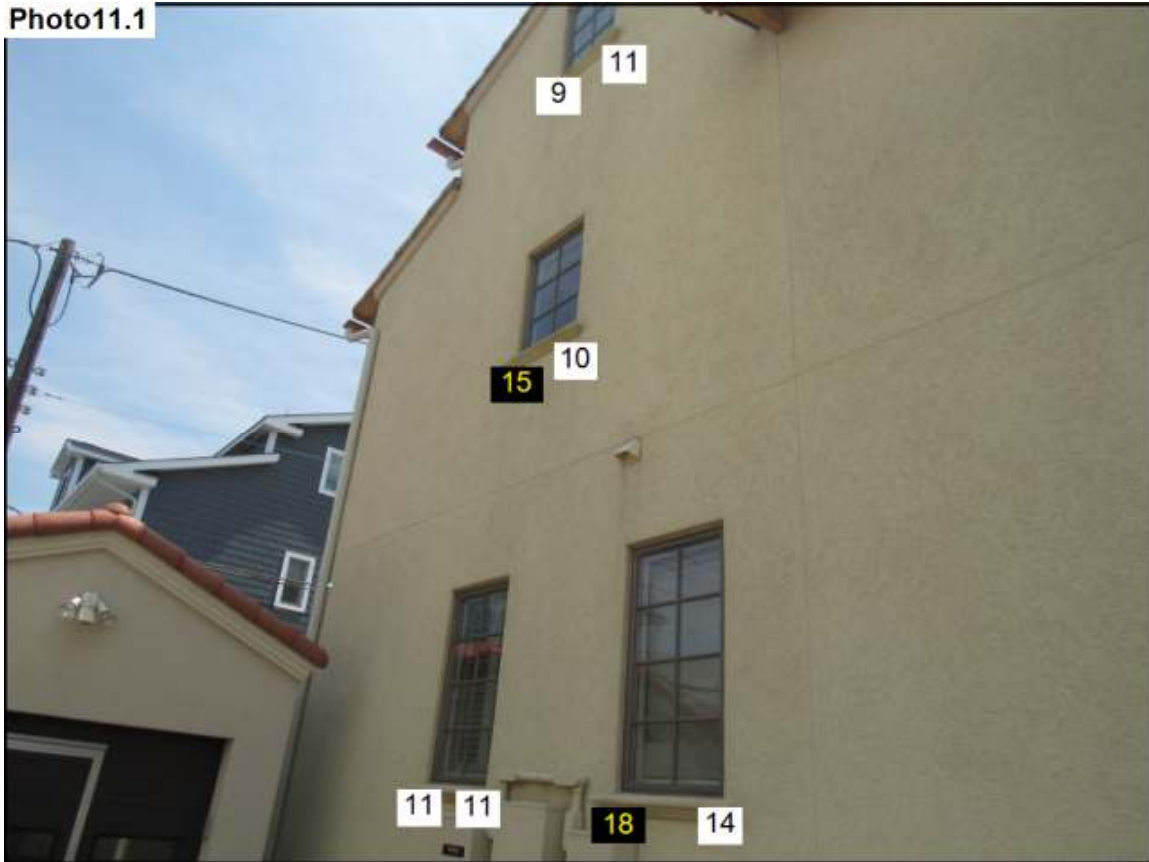
Photo11.1

| Item | Item Description | Applies to Entire Bldg | Observations / Comment |
|---|---|---|---|
| | General | | Marginal readings were measured on this section. |
| | Soft Joints/Caulk Details | | Soft joints were installed. |

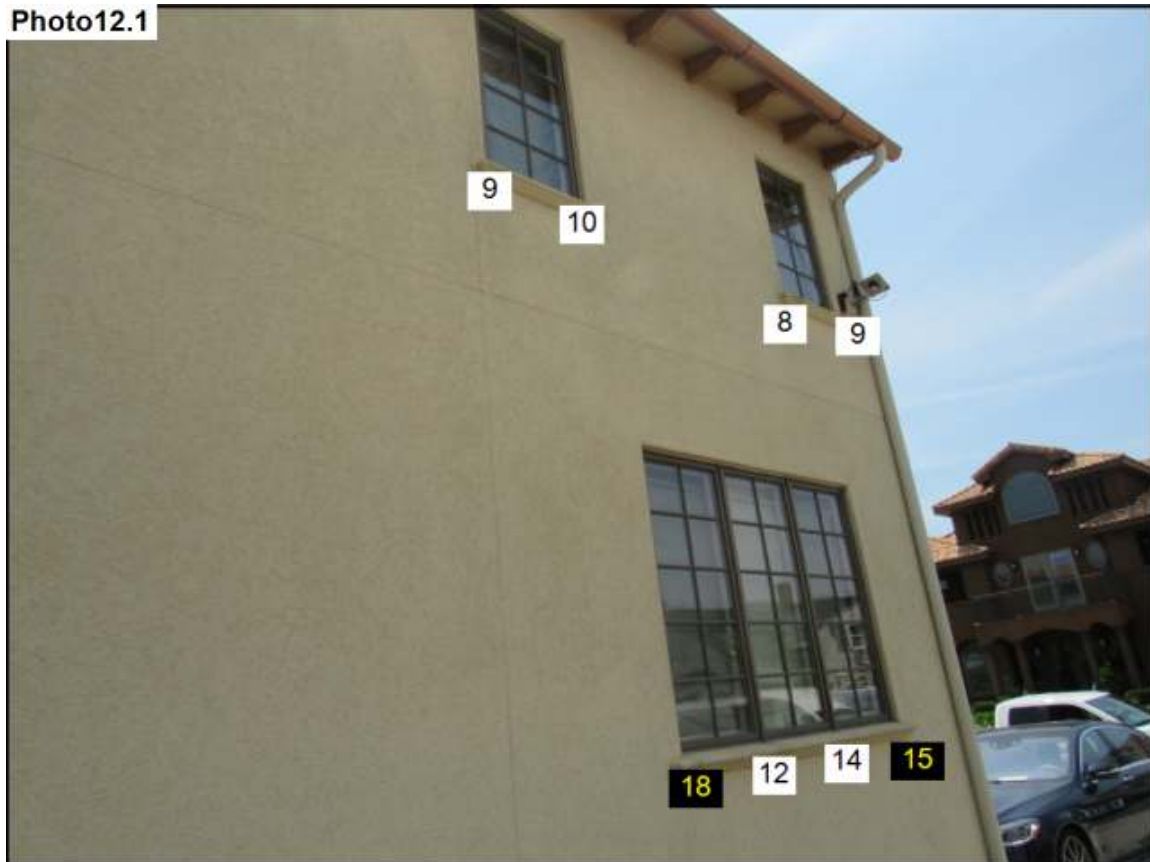
Photo12.1

| Item | Item Description | Applies to Entire Bldg | Observations / Comment |
|---|---|---|---|
| | General | | Marginal readings were measured on this section. |
| | Soft Joints/Caulk Details | | Soft joints were installed. |

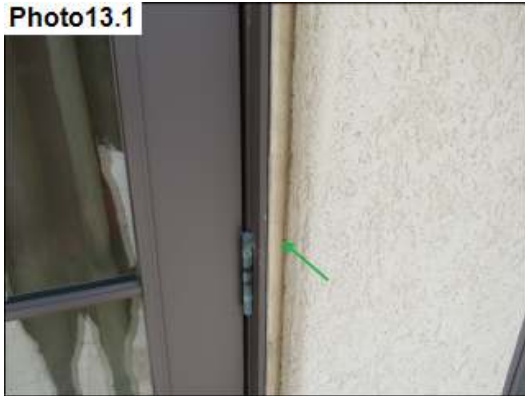
Photo13.1

Soft joints were installed around the doors.

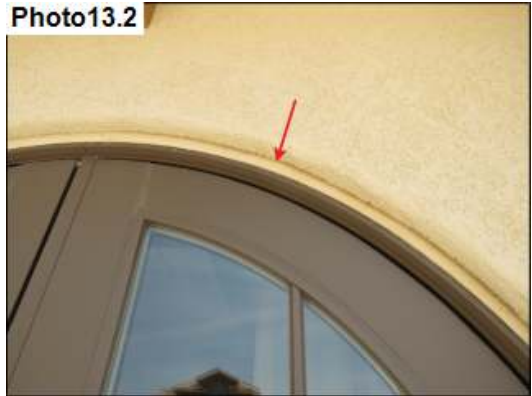
Photo13.2

4. Head Flashing - Head flashing was not installed on the windows and doors. The purpose of a head flashing above a window or door is to allow moisture to escape and prevent potential pockets of high moisture concentration around the windows.

Head flashing was not installed on the doors.

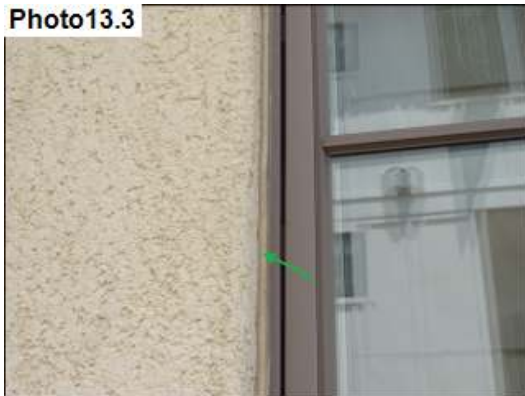
Photo13.3

Soft joints were installed around the windows.

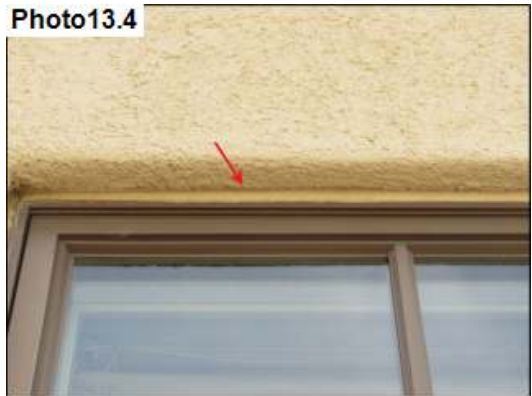
Photo13.4

Head flashing was not installed on the windows.

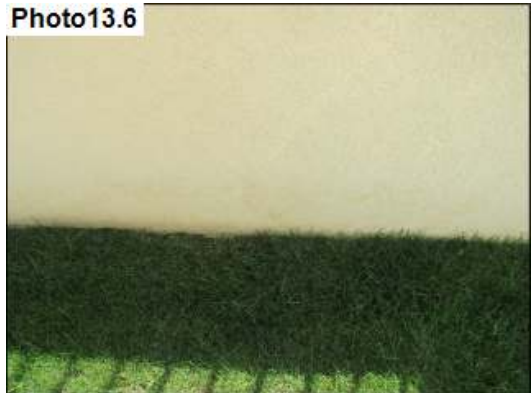
Photo13.6

Improper termination from stucco to grade, should have a 4" gap.

5. Clear mulch and landscaping as needed, so that there is a minimum 4" gap between the top of the landscape surface and the bottom of the stucco

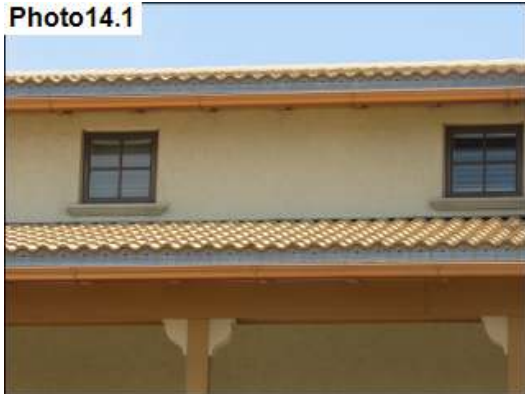
Photo14.1

Improper termination from stucco to roof, should have a 2" gap.

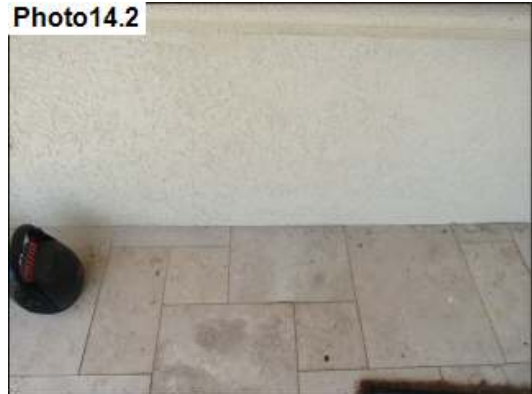
Photo14.2

Improper termination from stucco to slab, should have a 2" gap.

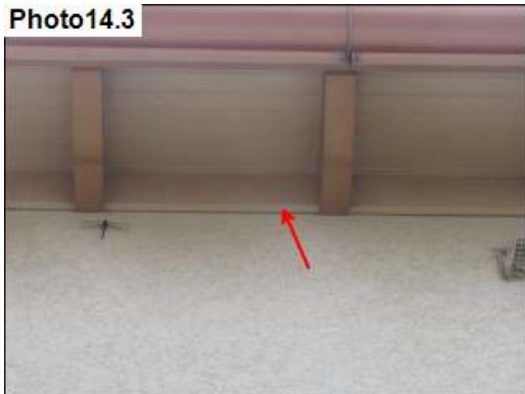
Photo14.3

6. Soffit/Fascia/Rake Intersections - The stucco intersection with soffit and fascia/rake boards were not sealed. Stucco industry details require fascia/rake boards to lap over stucco a minimum 1". If stucco is abutted to fascia/rake it should be sealed to prevent moisture intrusion due to wind-driven rain this is especially important in areas where there is a Gable "A" design. Any area or wall that is peaked is more susceptible to moisture infiltration without the proper details.

Sealant joint was not installed at fascia board.

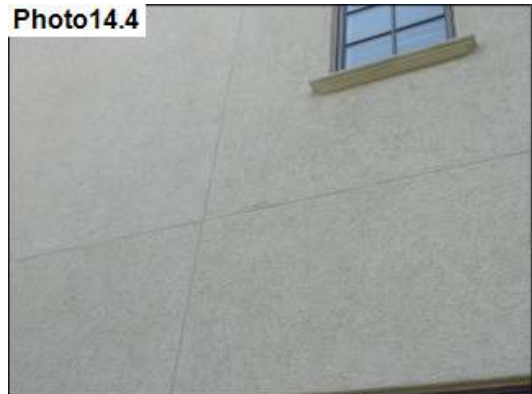
Photo14.4

Expansion control joints were installed.

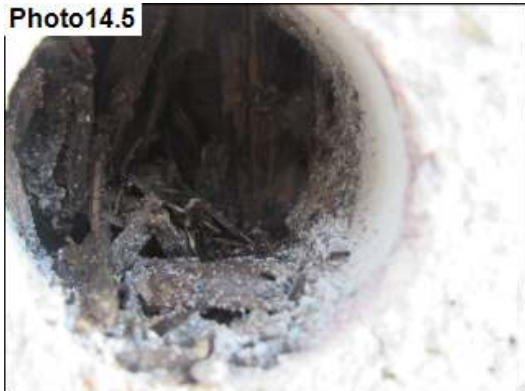
Photo14.5

Core 1 revealed rotted plywood.

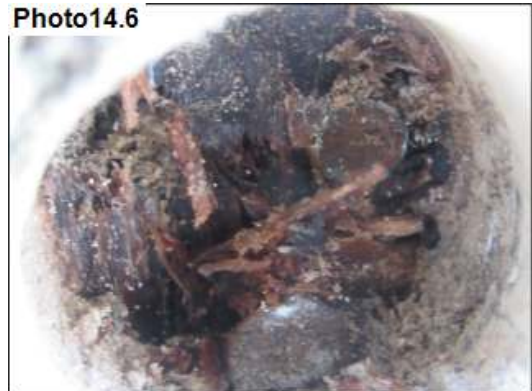
Photo14.6

Core 2 revealed damp plywood.
